Title of Investigation: LDS Church Eagle Mountain	Investigation Number: 788035-20-0111	Report Number: 2
--	---	---------------------

ORIGIN AND CAUSE REPORT

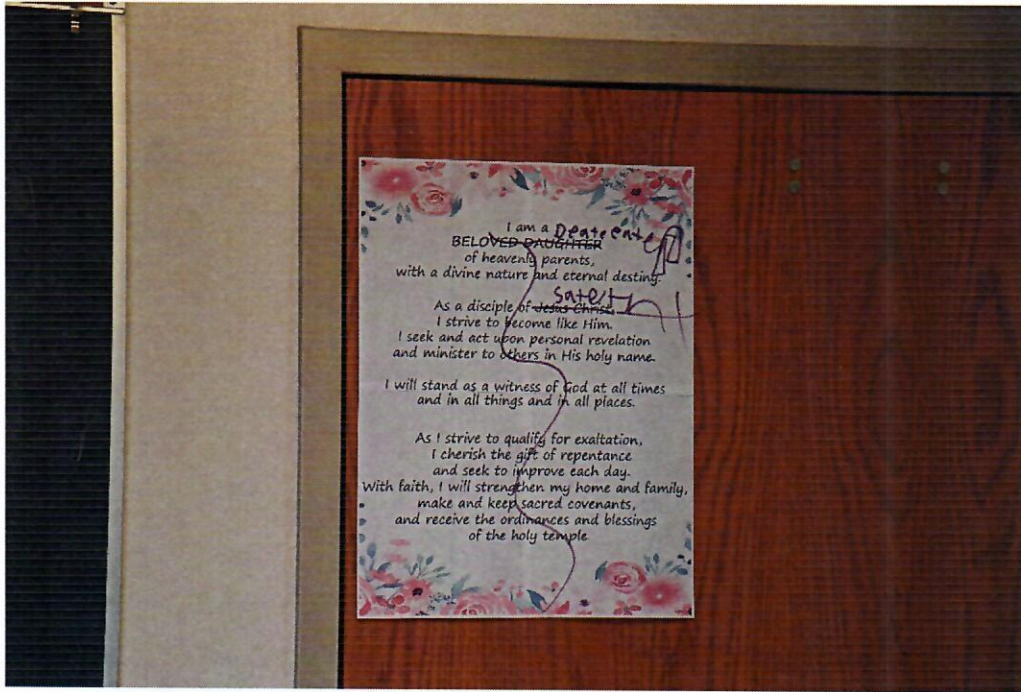
19. Investigators walked through the building checking the rooms and hallways for any damage.
20. On the east side was a large room used for Young Women meetings. The north window to this room was ajar and it appeared a suspect or suspects made entry into this room. There was unreadable writing in marker on the window base plate inside the room. There was juvenile writing on a poster in the

room and white board. There was additional juvenile writing on a white board located in the west side hallway. There were markers on the ground near the white board in the west side hallway.

Writing on poster.

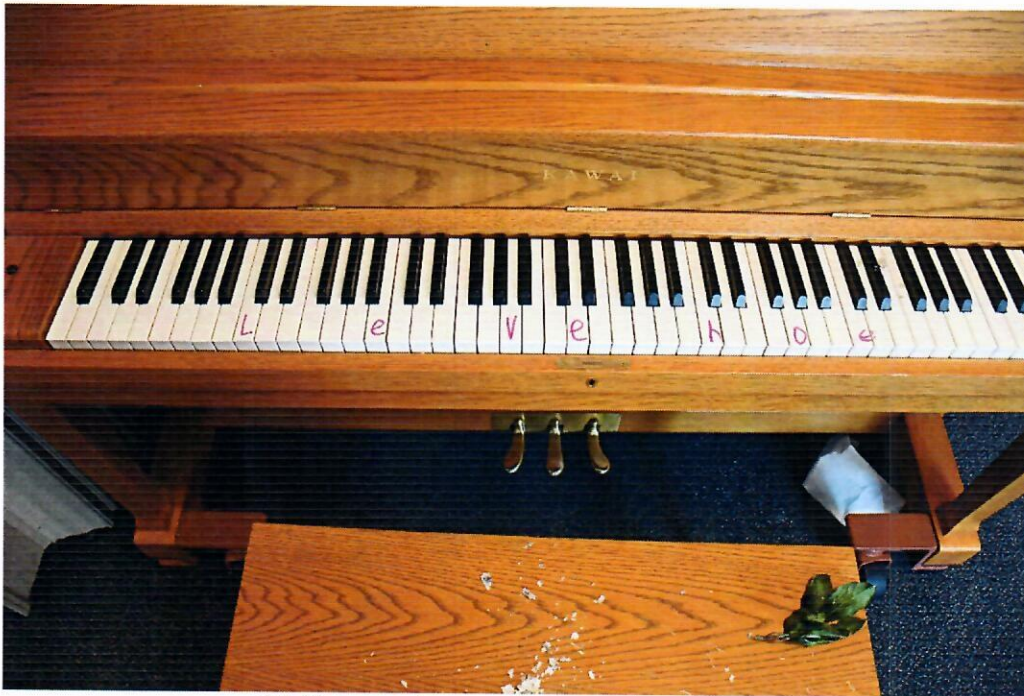
21. There was marker writing on the piano keyboard and ash on the piano bench. From this location, there was ash on the hallway carpet outside this room and additional ash on the hallway carpet leading towards the chapel.

Writing on piano and ash on piano bench.

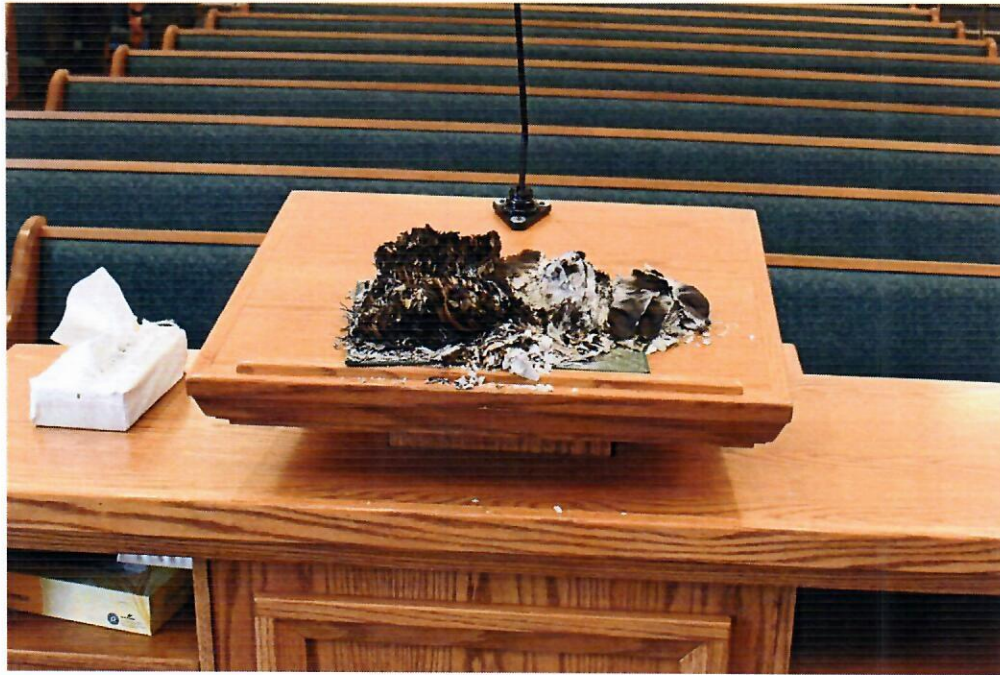
Pulpit.

22. In the chapel, investigators observed a hymnbook on the pulpit that was fanned open and charred.

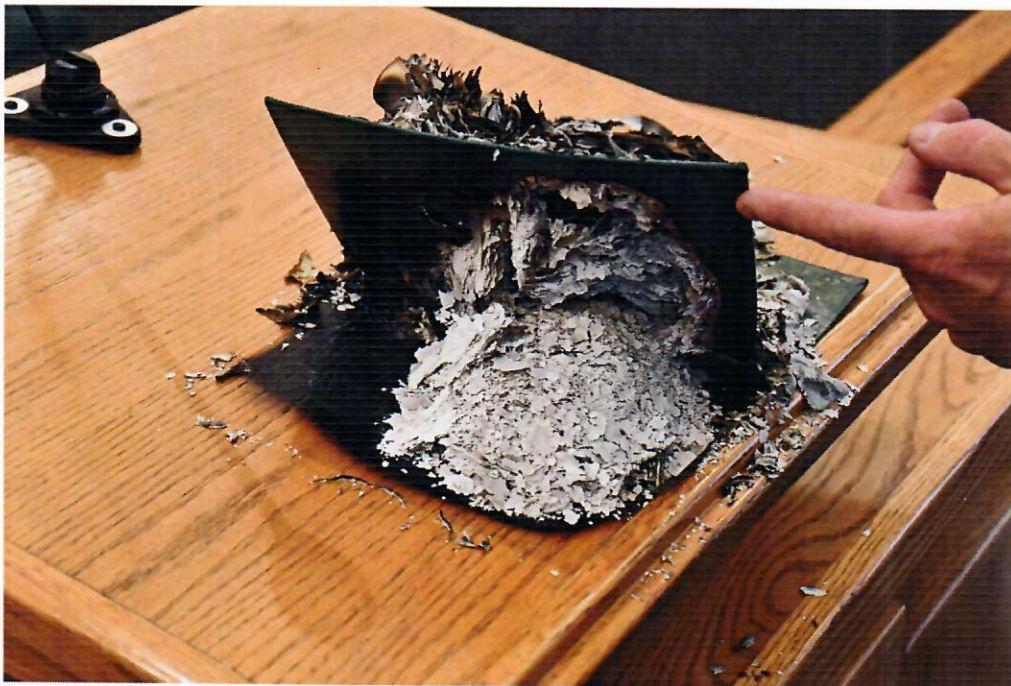
Bottom of hymnbook.

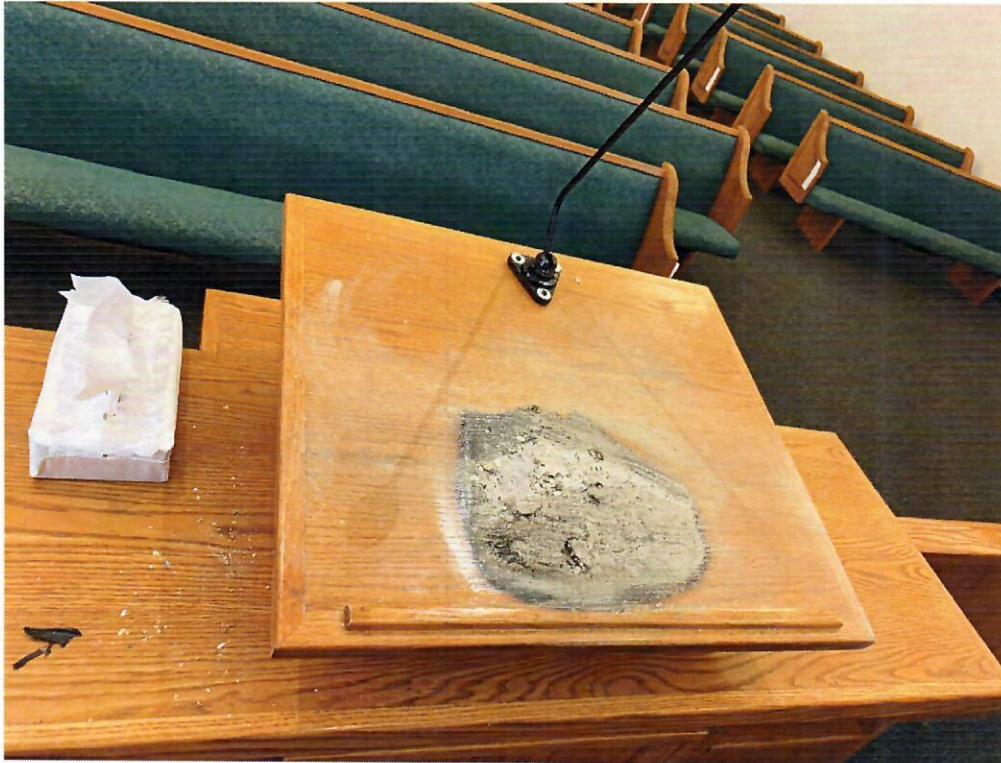
23. The wood on the top of the pulpit under the hymnbook was charred from the top down. The fire self-extinguished after consuming the light-weight paper from the hymnbook.

Charring on pulpit underneath hymnbook

32. Based upon the information available at the time of this investigation including evidence left at the scene, fire patterns, and fire dynamics, investigators determined the area of origin to be the hymnbook from the piano in the Young Women's room. The hymnbook was moved from this location to the pulpit in the chapel.

33. Based upon the evidence recovered at the scene, witness statements, knowledge of fire patterns and fire dynamics, investigators have concluded that the fire began when human hands, used a transient ignition source, consisting of an open flame, and applied it to available combustible materials.
